They are rotary vane vacuum pumps, lubricated with oil recirculation, with a suction flow rate of 105 m³/h.

105LGD1			
Frequency		50Hz	60Hz
Flow rate	m ³ /h	105	126
Ultimate pressure	mbar	65	
Motor performance	3~	230/400±5%	265/460±5%
Volt	1~		
Motor power	3~	3,00	3,50
kW	1~		
Motor protection	IP	55	
Rotation speed	rpm	1450	1750
Motor shape		B5	
Motor size		100	
Weight	kg	94

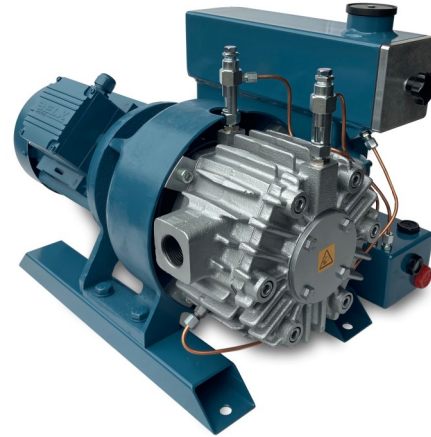
The pump rotor and shaft are a single piece, supported by independent bearings mounted within the two pump end flanges. The pump and electric motor are thus two independent units, fixed to a dedicated support and connected to each other by an elastic coupling.

The pump is cooled by a radial fan located between the motor and the pump.

On the pump discharge, there is an oil recovery tank containing a separator filter that prevents the formation of oil mists and reduces noise.
